# Manhole Inspection Summary

Manhole # S23AA2004MH

Insp Date: **11/9/06 10:43 AM**

**Location** Address: **1012 NORTHERN PWY**

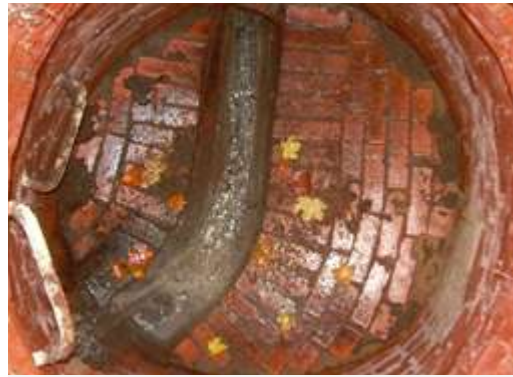
Top View

Corroded steps. Bench debris.

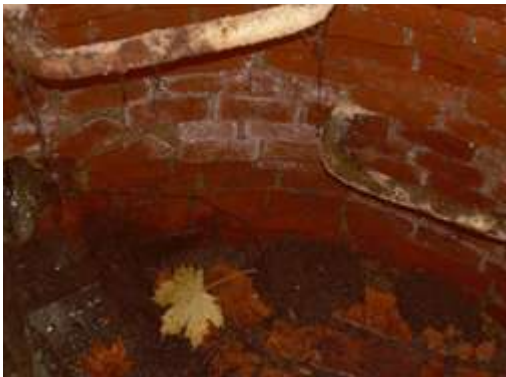
Defect

Condition: ☐ Sound ☐ Cracked ☒ **Root Intrusion** ☐ Loose Brick ☐ Deteriorated

Infiltration: ☐ None ☐ Joint ☐ Cracks ☒ **Mortar** ☒ **Roots** ☒ **Wall**

Barrel root intrusion and infiltration.

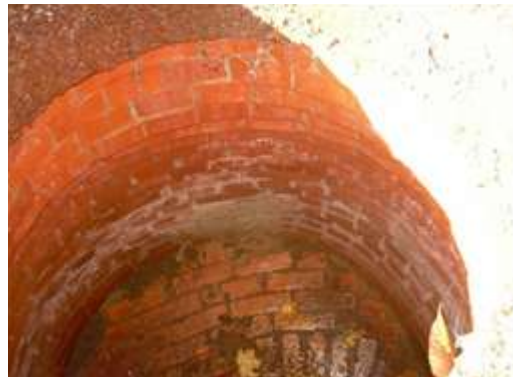
Defect

Infiltration: ☐ None ☒ **Joint** ☐ Cracks ☐ Mortar ☐ Roots ☐ Wall

Adjustment and Barrel infiltration.

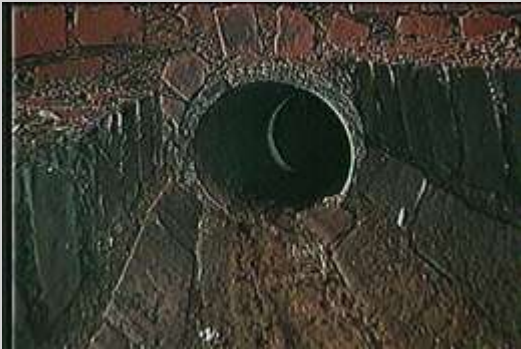
### 8 in. Circular Gravity Sewer Pipe Out @ 12 O'Clock

Channel deterioration.

Deposits: ☐ None ☒ **Mud** ☐ Sludge ☐ Debris ☒ **Grease**

Silt Depth: **0.5** (in.) Deposits Extent: **Light**

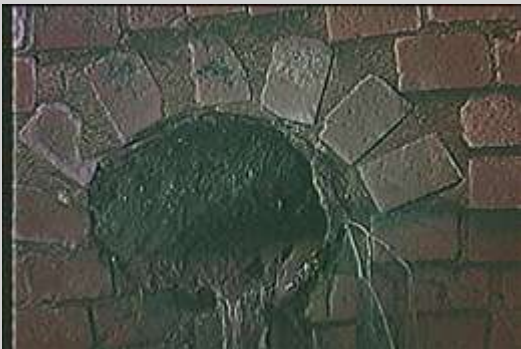
### 8 in. Circular Gravity Sewer Pipe In @ 7 O'Clock

Infiltration: **Evidence** Pipe Seal Cond: **Roots**
